# GMV5

GREE MULTI VRF SYSTEM

## GMV5 Key Parts Maintenance

Overseas Sales Co, GREE

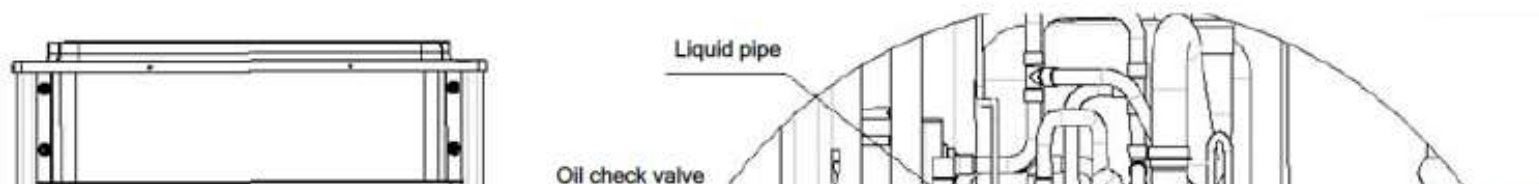
# Structure Schematic

**GMV-224WM/A-M**

**GMV-280WM/A-M**

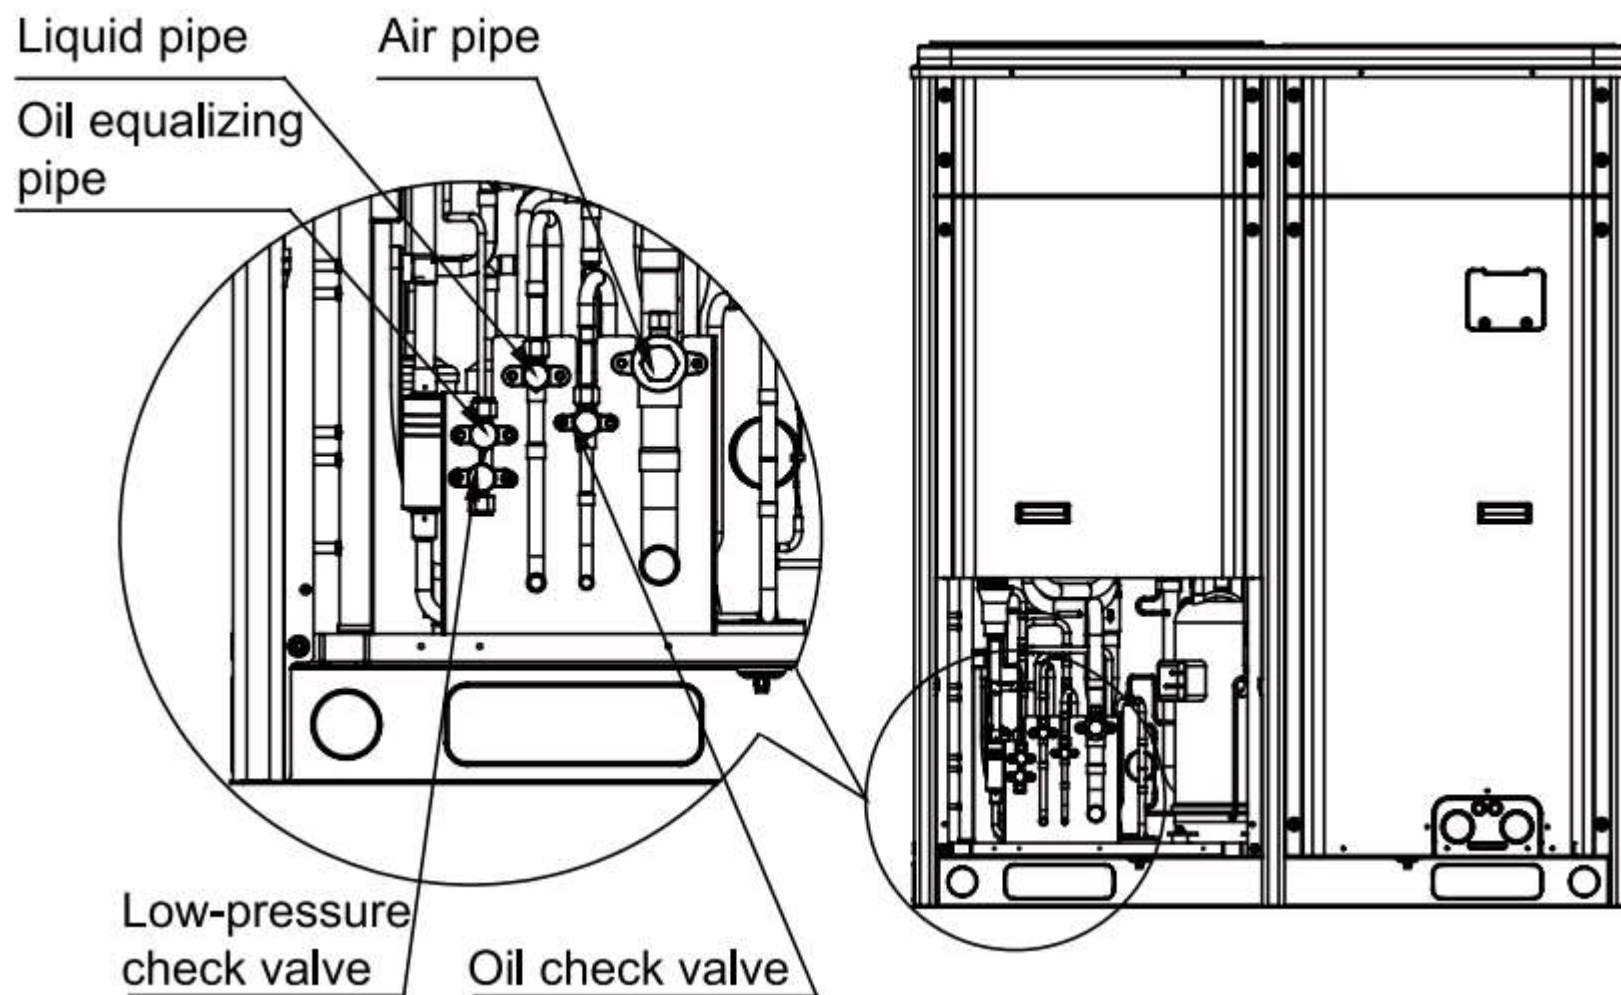
# Structure Schematic

## GMV-335WM/A-M

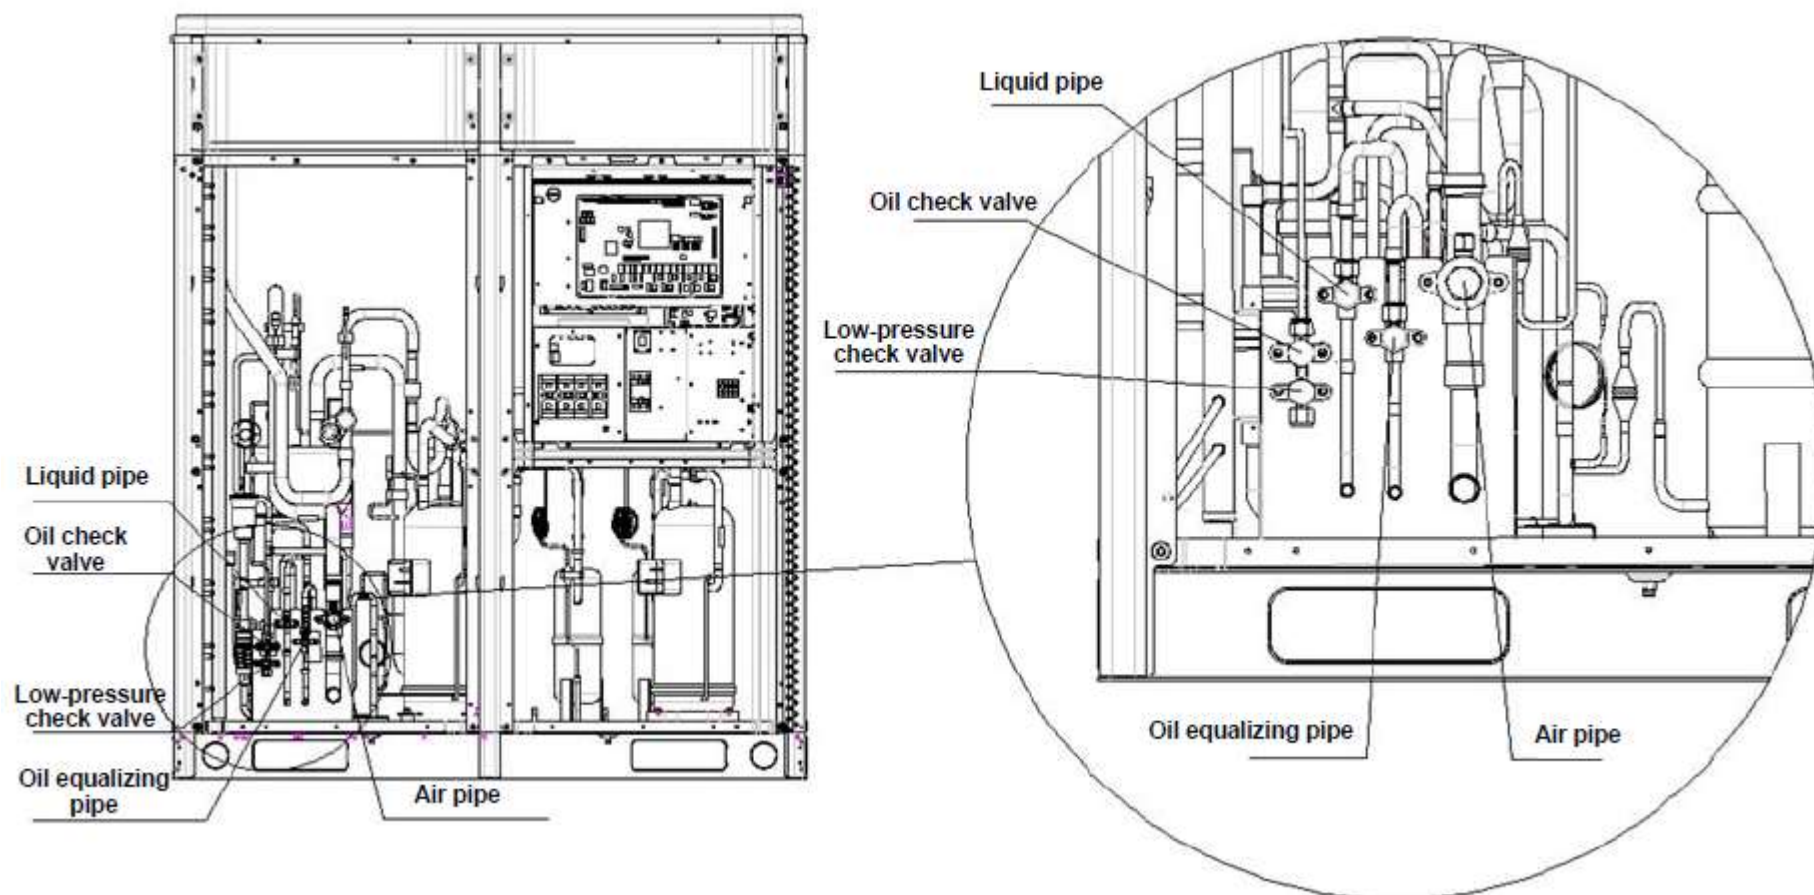
# Structure Schematic

**GMV-400WM/A-M**

**GMV-450WM/A-M**

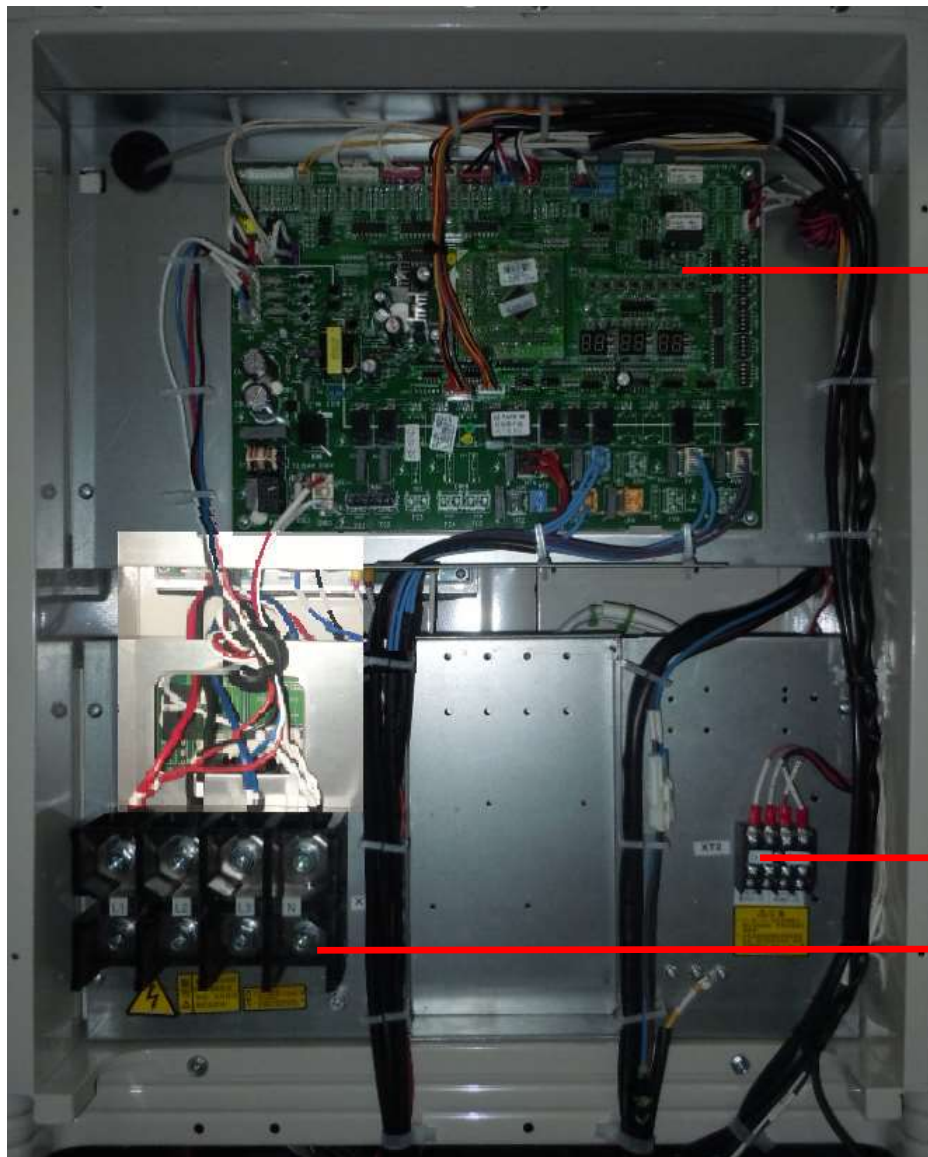
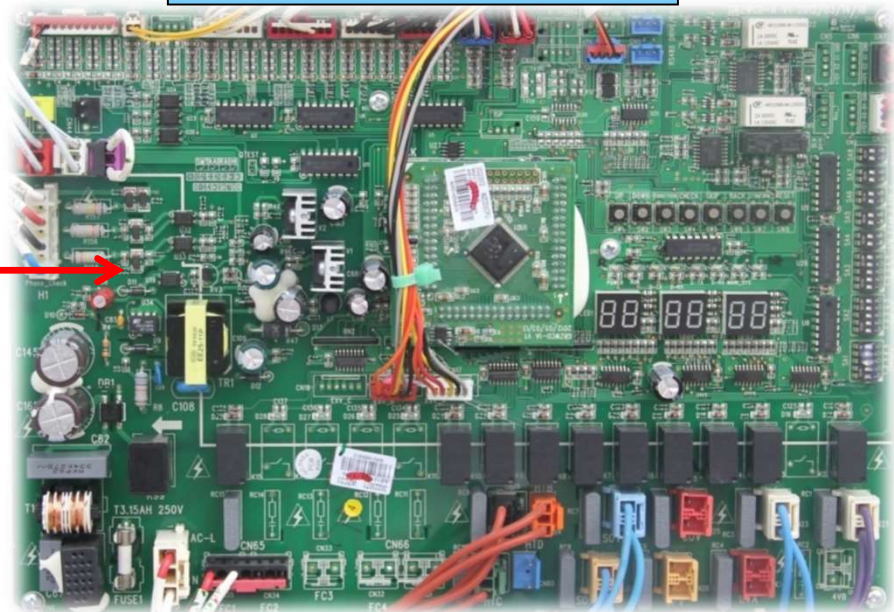
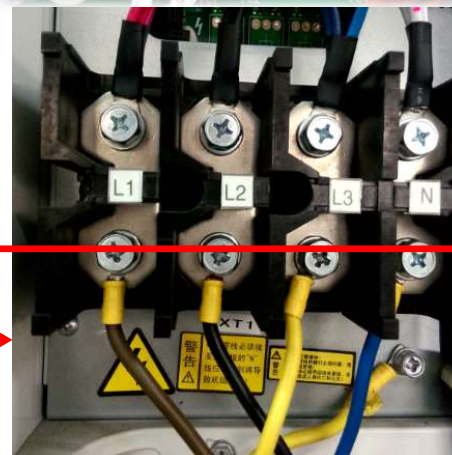
Main board AP1

Power supply wiring board XT1

Communication wiring board XT2

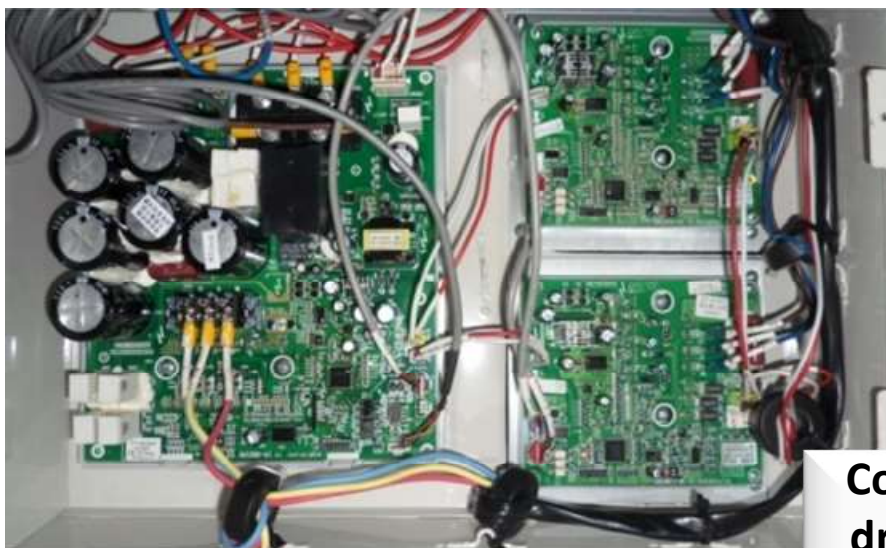
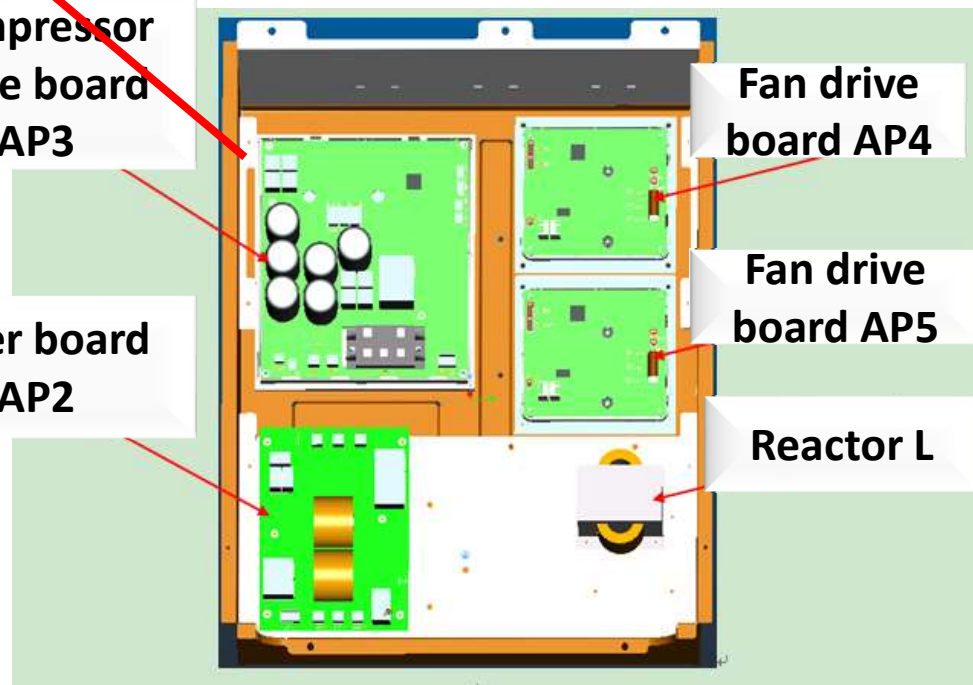
Compressor  
drive board  
AP3

Filter board  
AP2

Fan drive  
board AP4

Fan drive  
board AP5

Reactor L

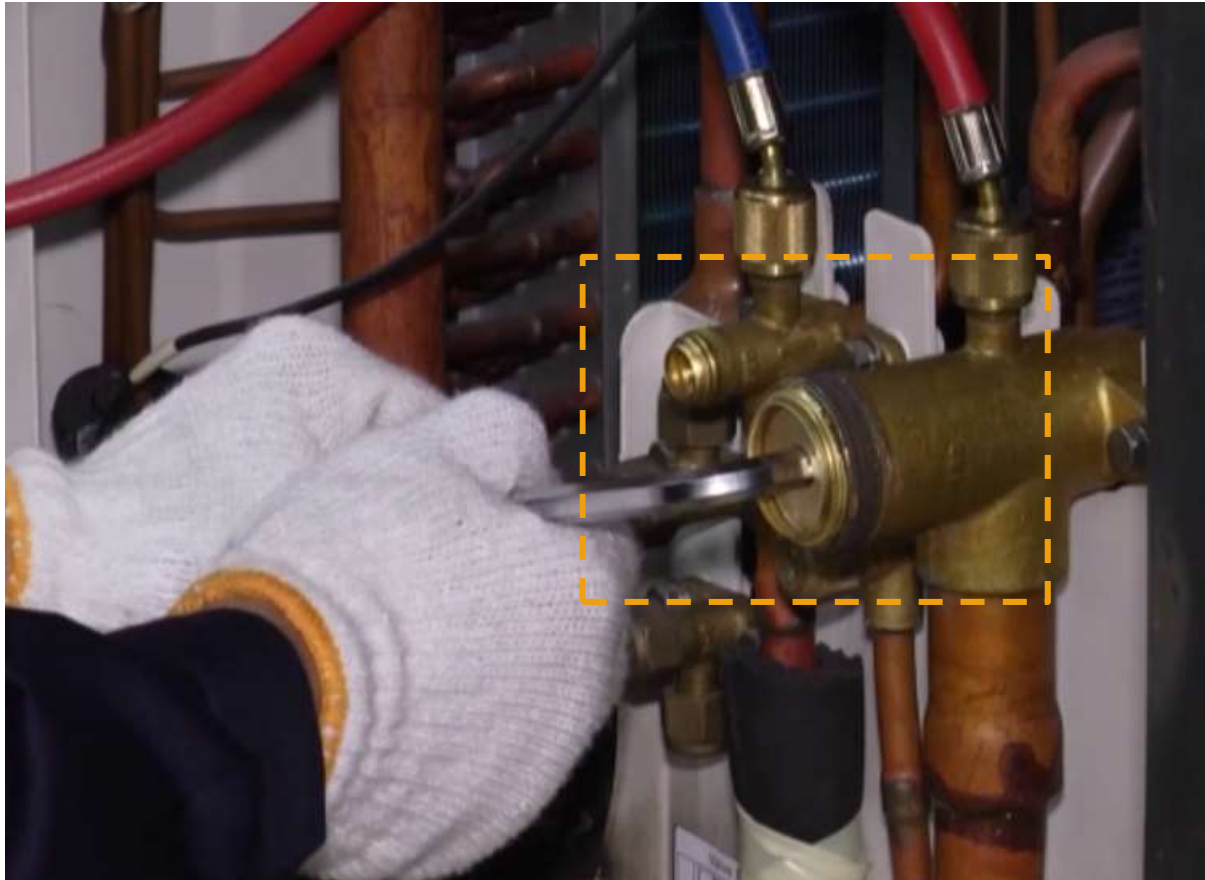
1. Gas and liquid valves should be opened fully.

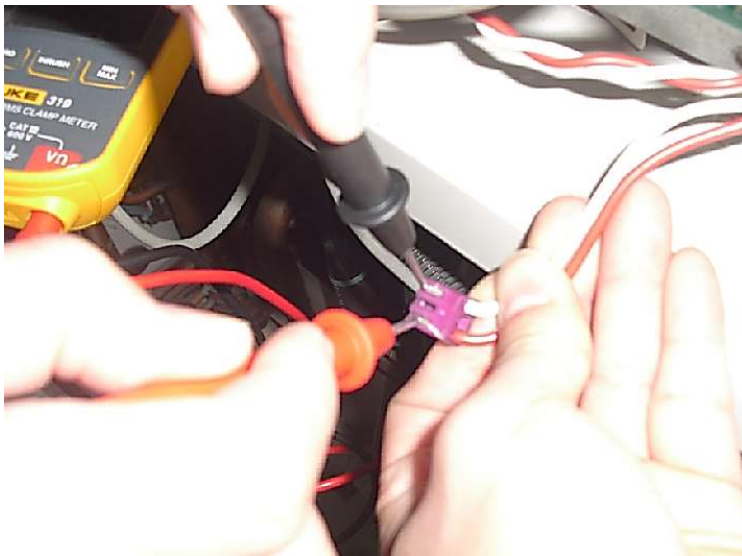
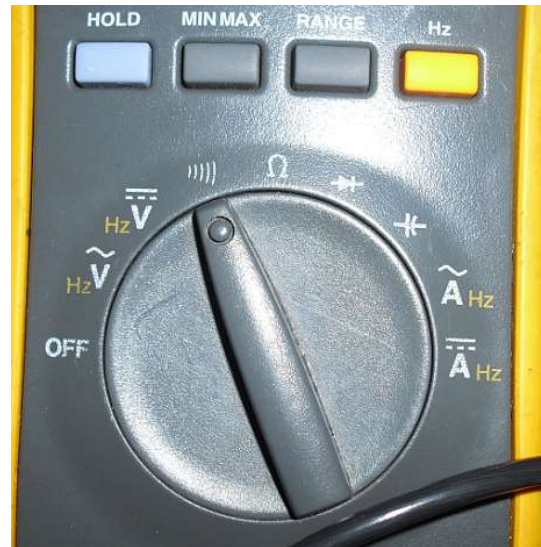
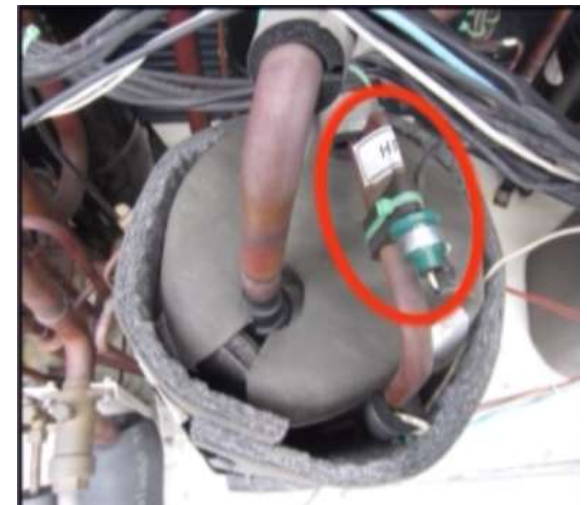
### 6. Check pressure switch

**No Beep!**

pressure  
switch failed

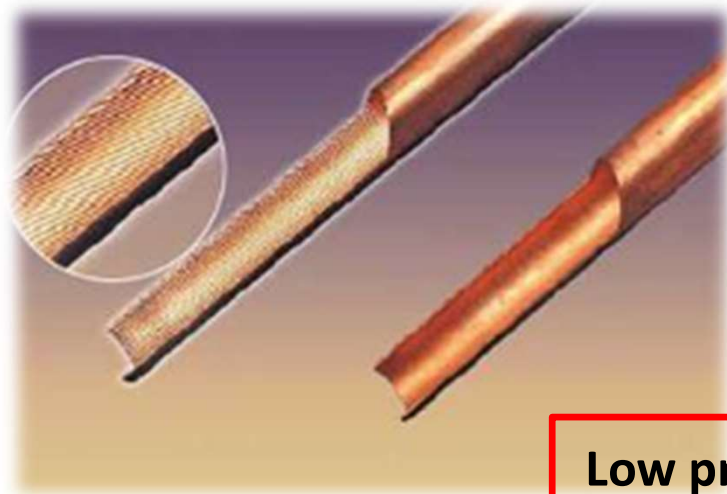
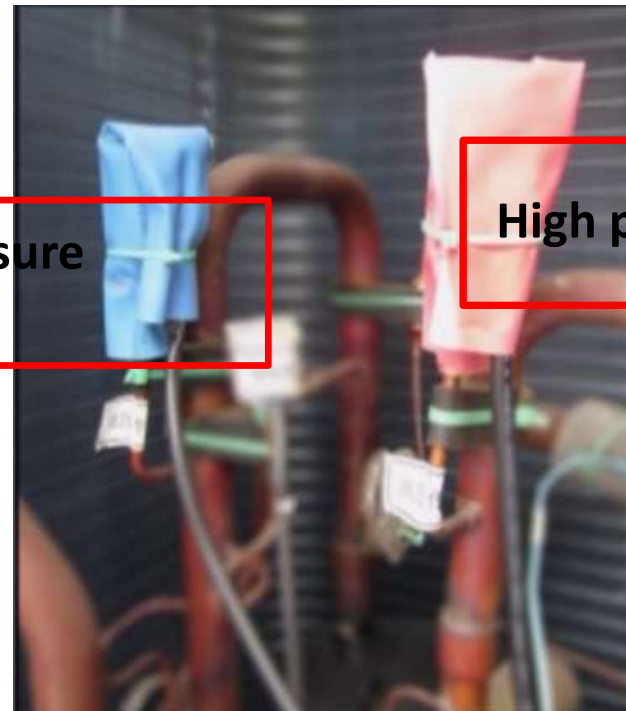
### 7. No block in piping system

Low pressure  
sensor

High pressure sensor

### 8. Pressure sensors are normal

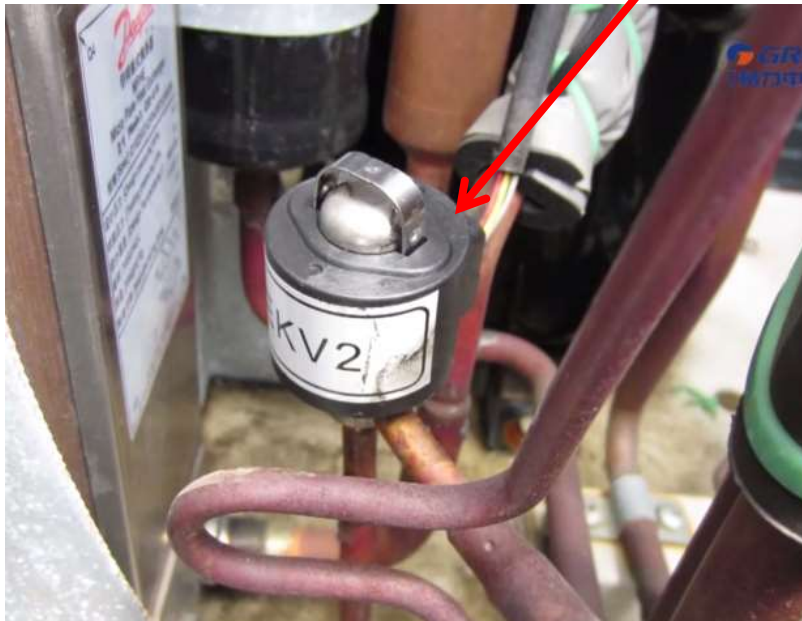
Make sure the coil is firm and fixed

Outdoor unit's EXV

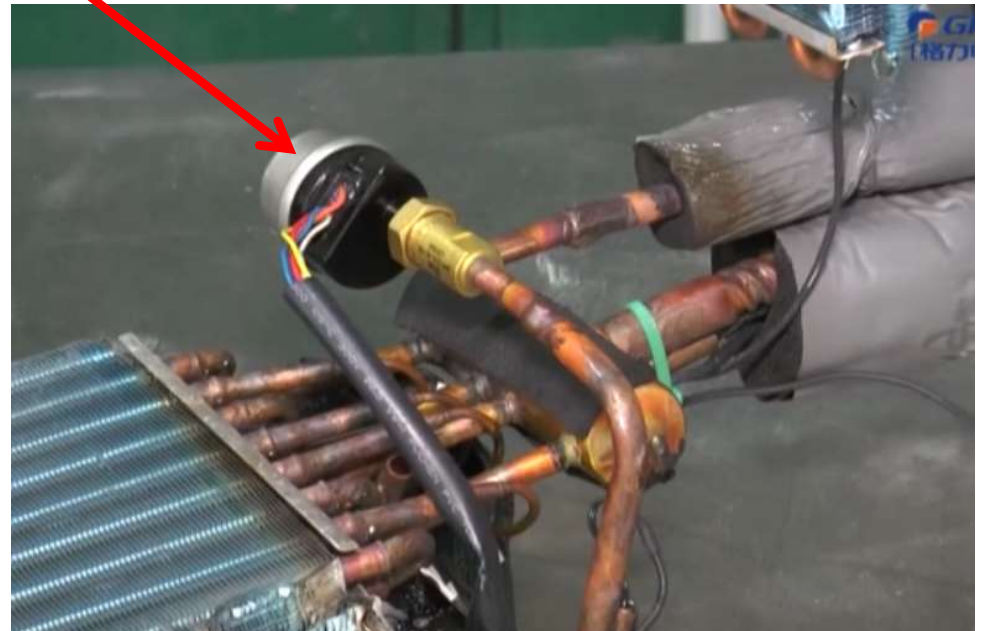
Indoor unit's EXV

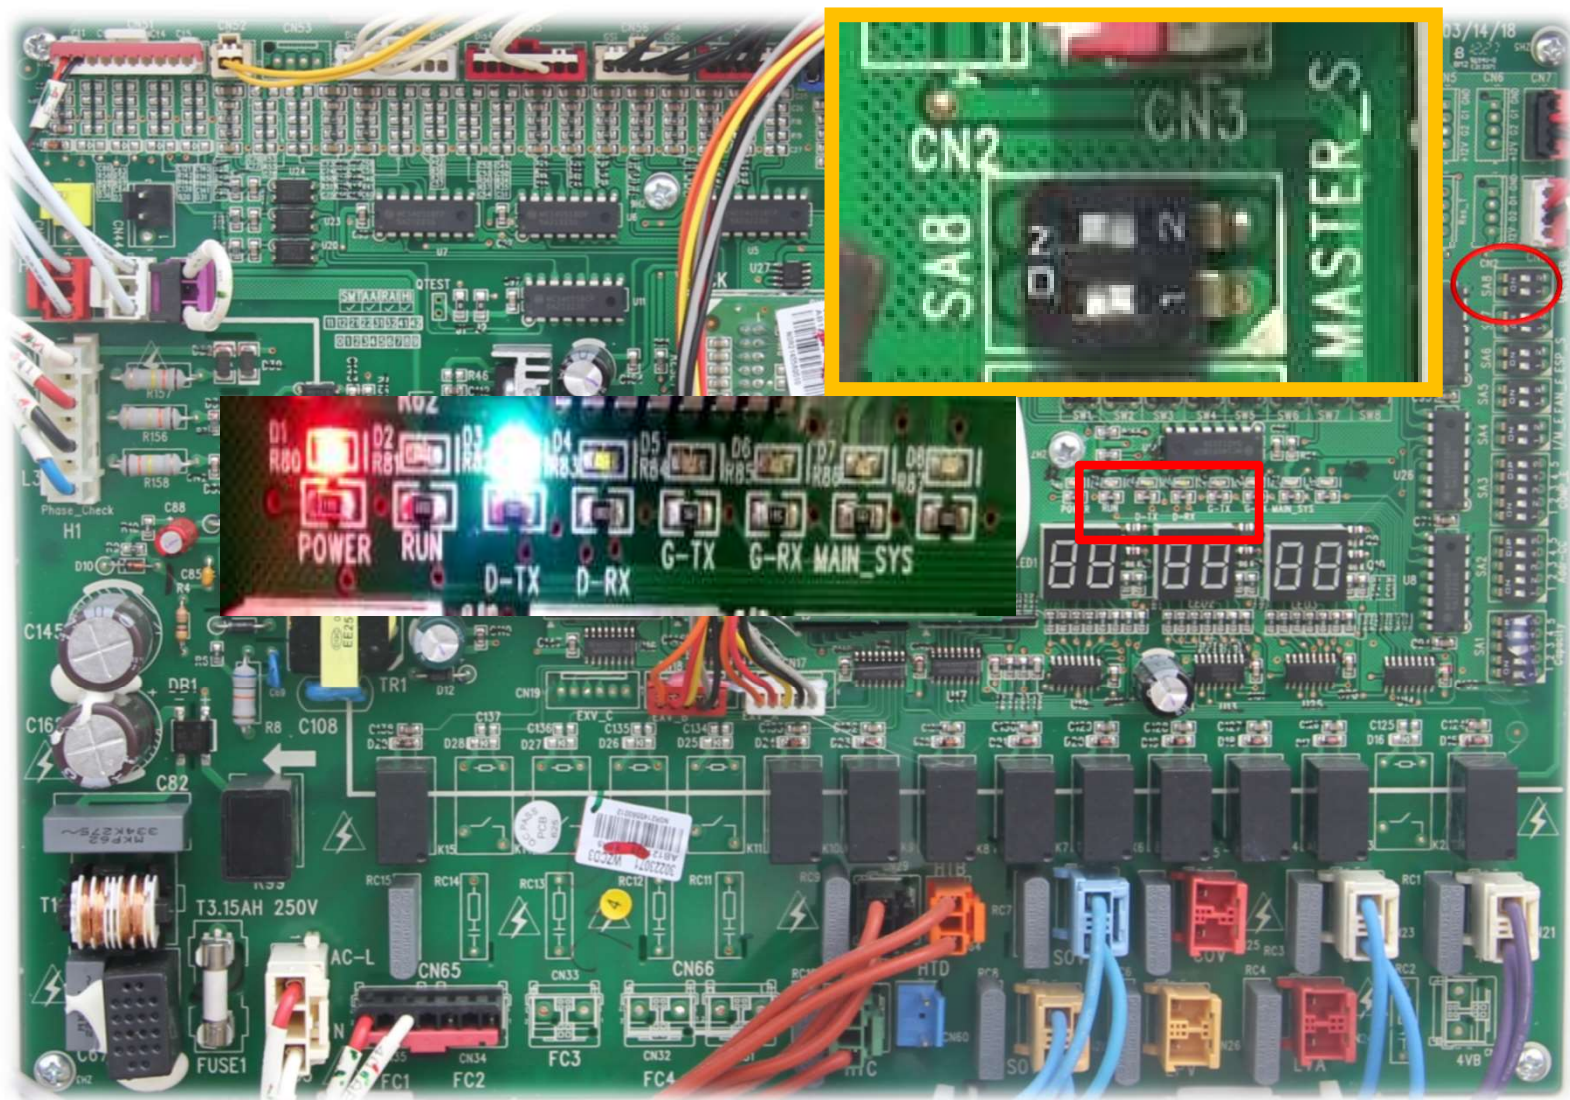
# I. Cautions on ODU AP1 Replacement

1. After AP1 is replaced, **you should power on the ODU and IDUs at the same time or power on the ODU first**; otherwise, “CC: does not have module” will display and a “C0 fault” alarm will display on the IDUs.
2. **Debug the entire system** after master module AP1 replacement, but commissioning is not needed when replacing the slave module.

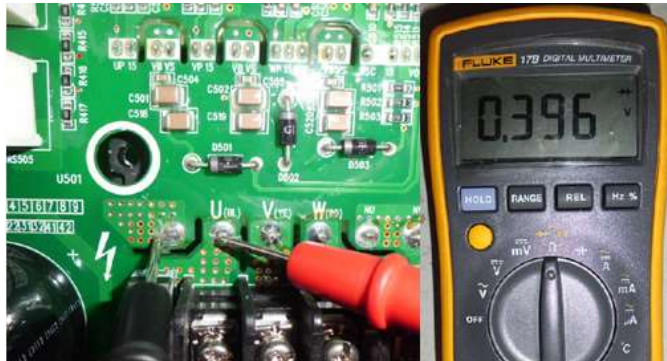
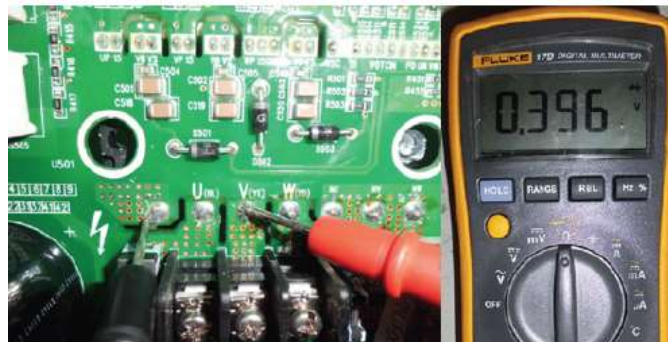
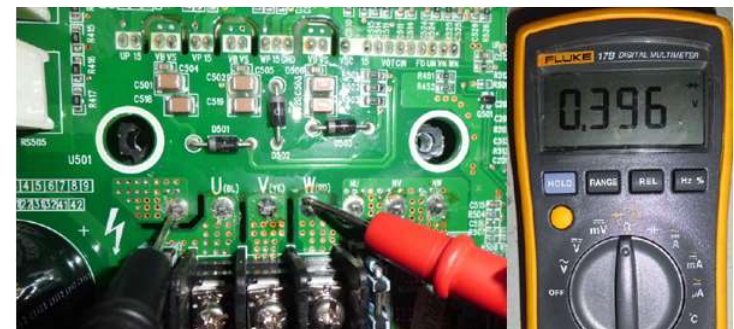
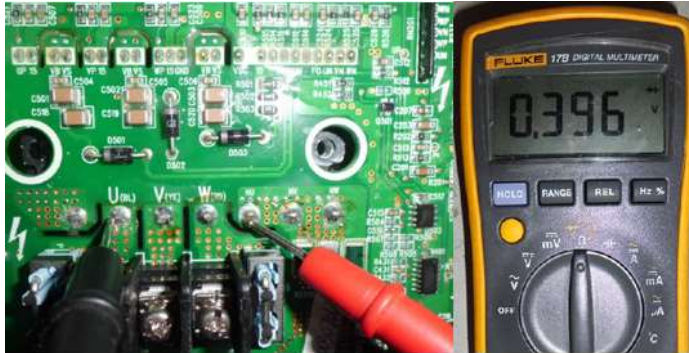
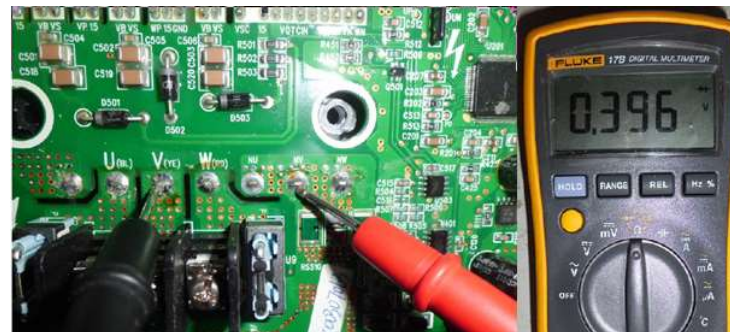
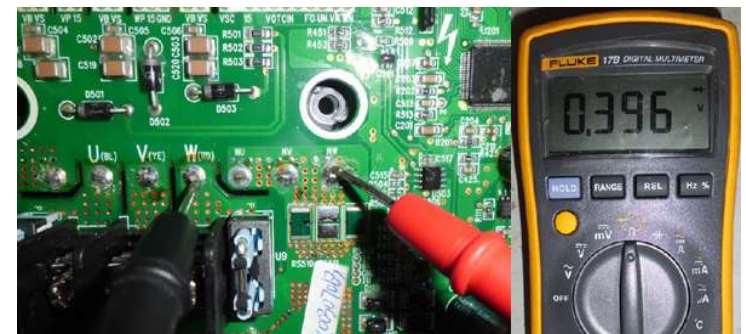
#### How To Test the IPM Module

**Note:** Before testing , disconnect the power supply, five mins later, remove the line of the faulty compressor

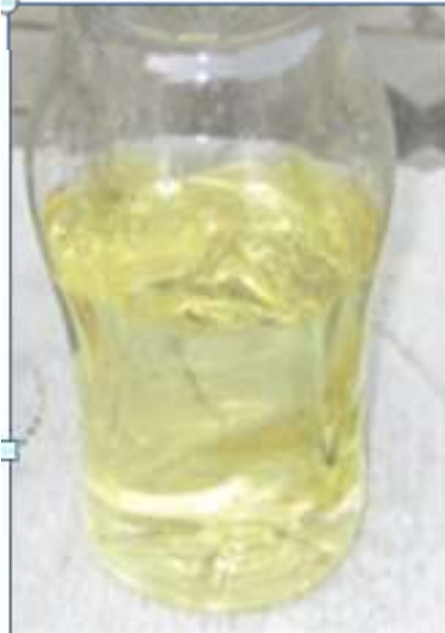
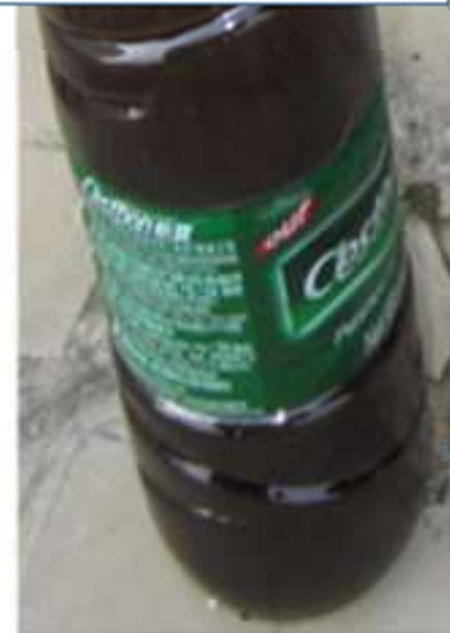
### Oil quality checking

normal

light contaminated

heavy contaminated

1. If oils are contaminated(as picture 2), replace the **compressor, oil separator, and gas/liquid separator**.
2. If oil changes to black(as picture 3), **still need to check oils of other modular units**. The check procedure is similar to the preceding.

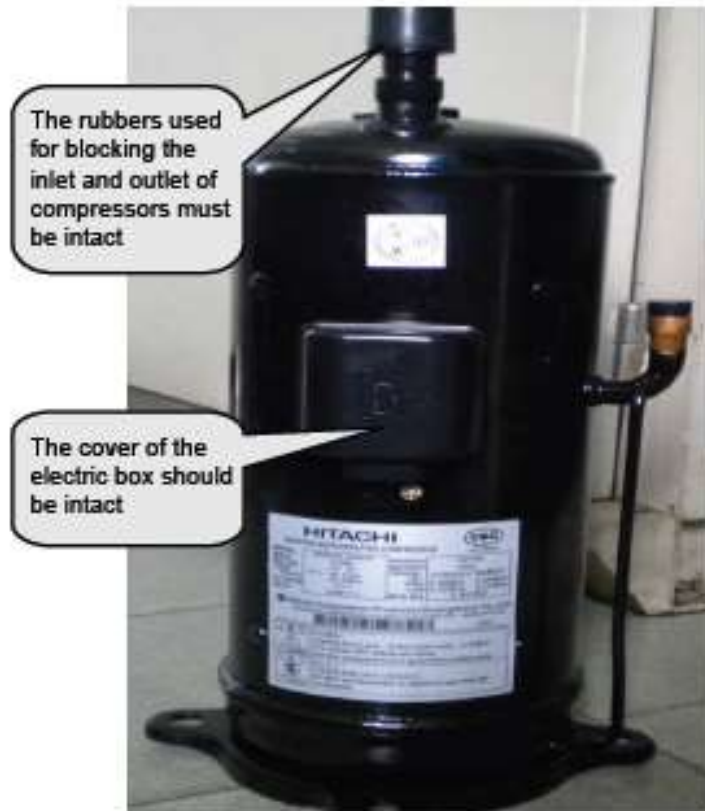
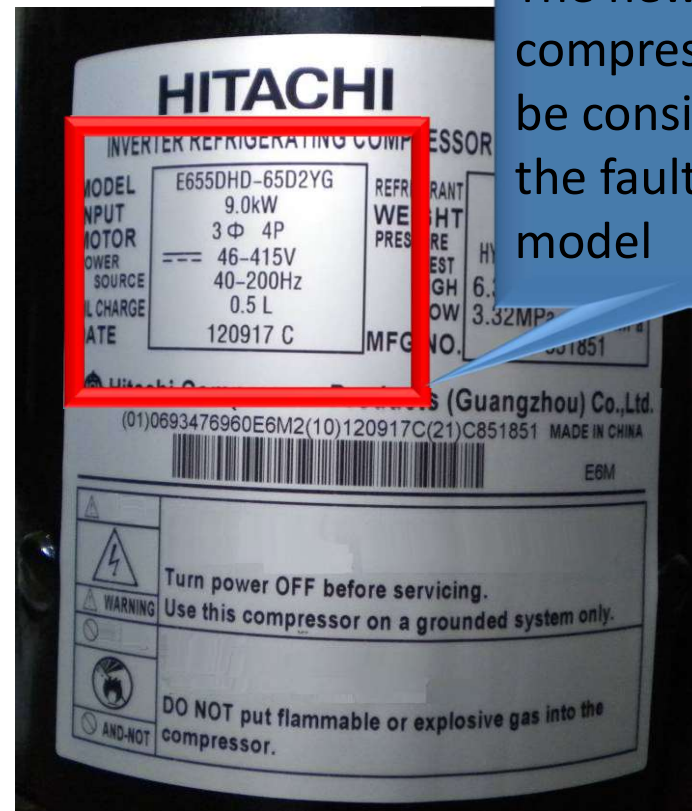
### ◆ Step 7: Install a new compressor

The new compressor must be consistent with the faulty one in model

**Note:** Compressor lubricant must be kept completely airtight, Hitachi compressors use special lubricant FVC68D whose moisture absorption capability is high

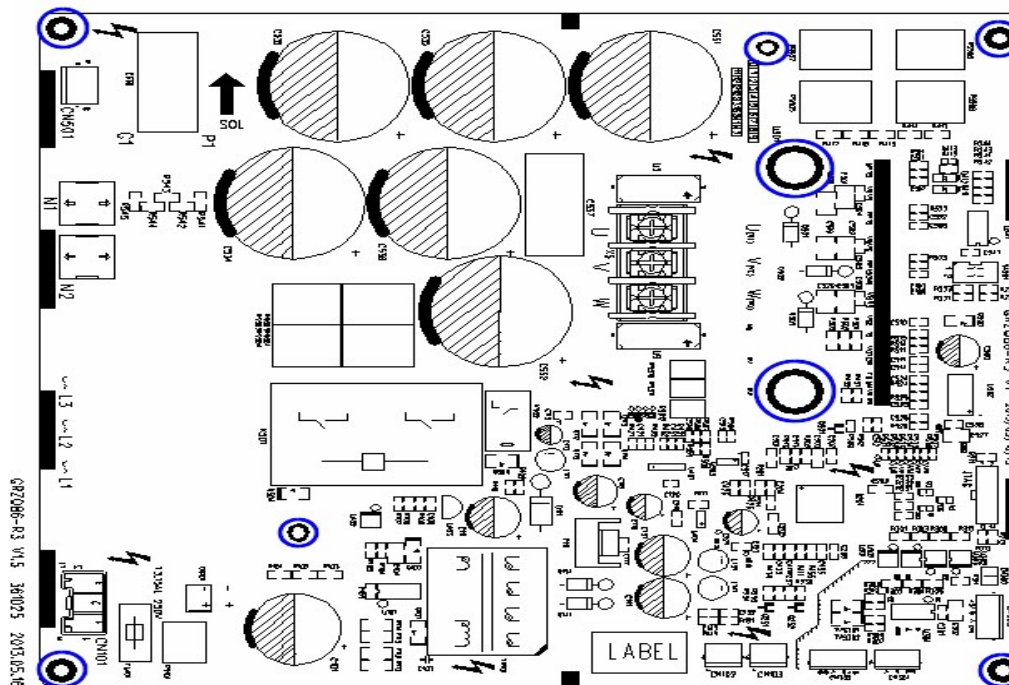
- ◆ **Step 1:** Disconnect the power supply of the system.  
Set a mark beside the power supply for warming.
- ◆ **Step 2:** Disconnect all lines of the compressor drive.  
Loosen the screws on the compressor drive, as shown below.

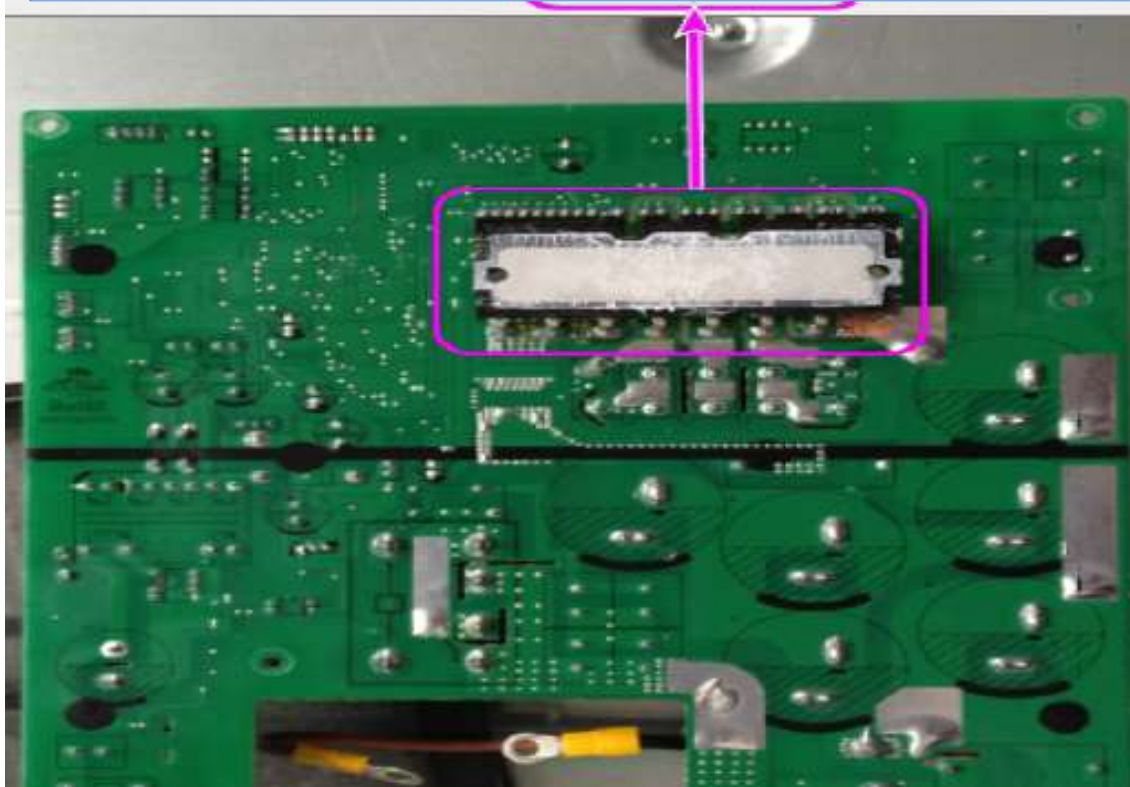
- ◆ **Step 3:** Replace the compressor drive.

Apply some silicone tape onto the IPM module

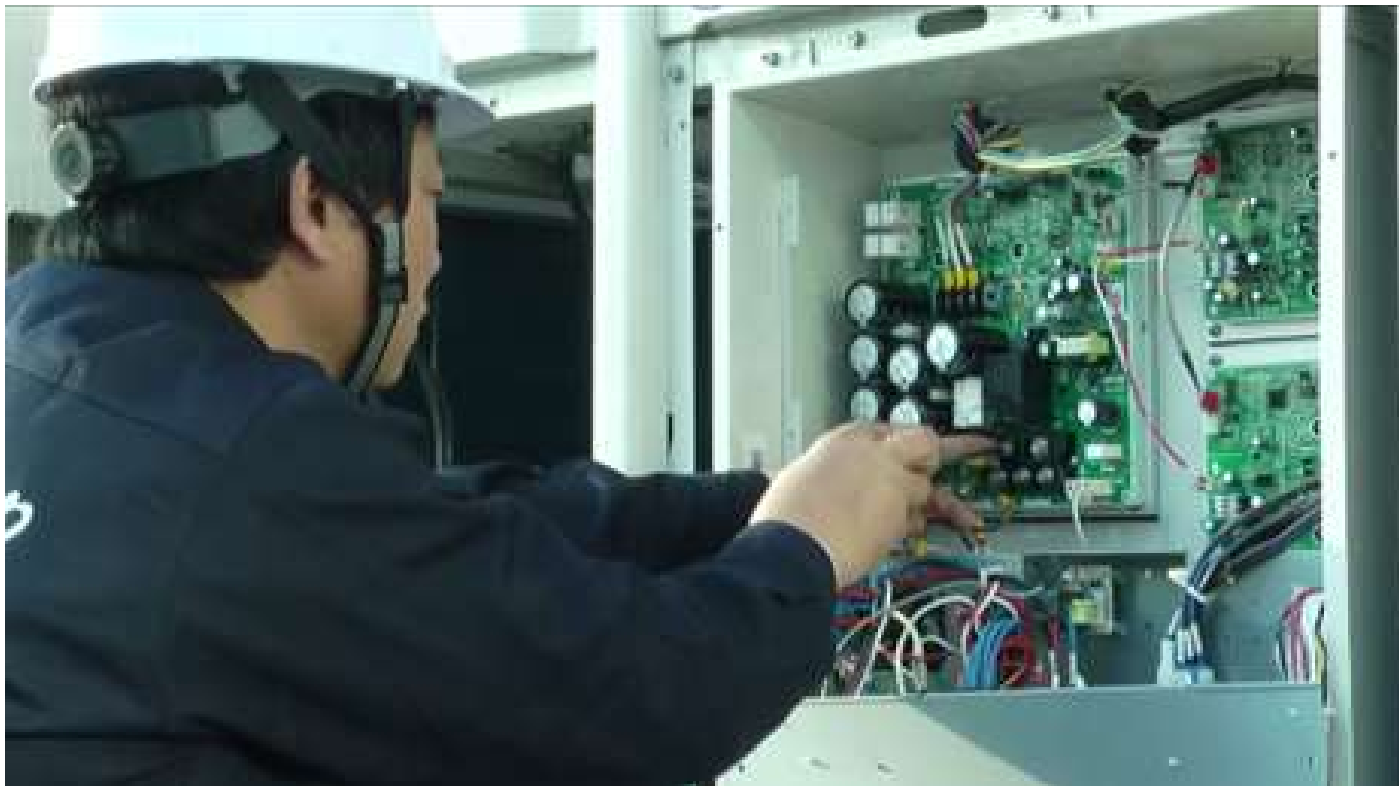
- ◆ **Step 4:** Install a new compressor drive, screw and wire it.

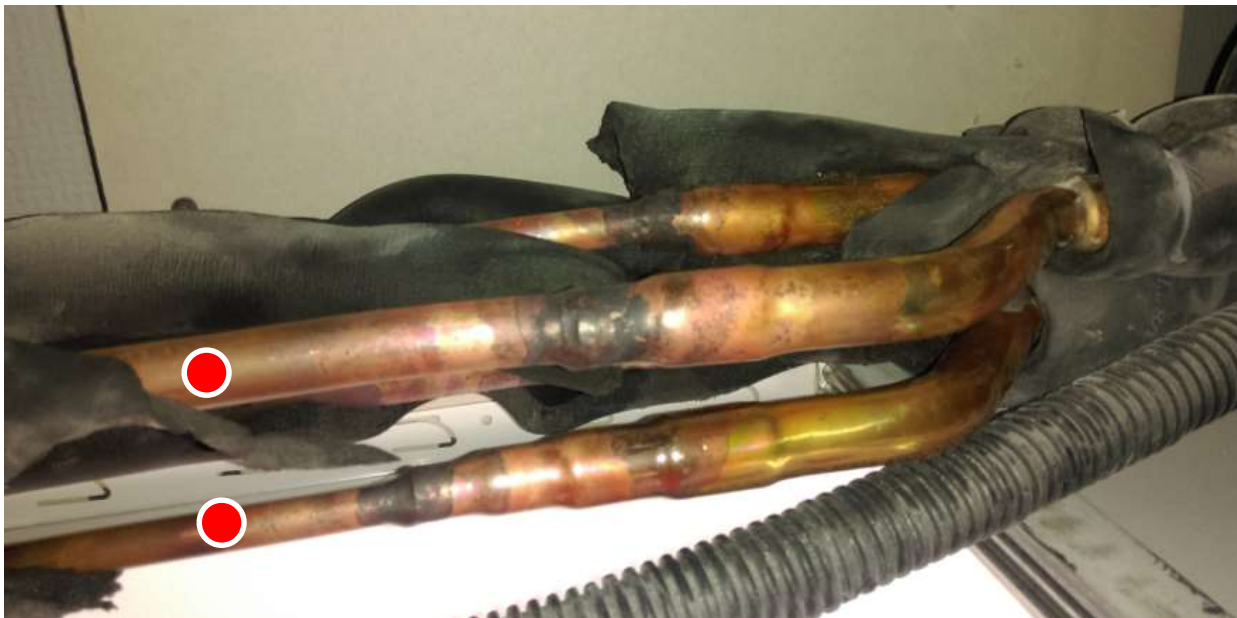
Thirdly, the reason is that the “Y” branch tubes(liquid pipe and gas pipe) of No.4 IDU are exchanged and joined by mistake. See the following picture.

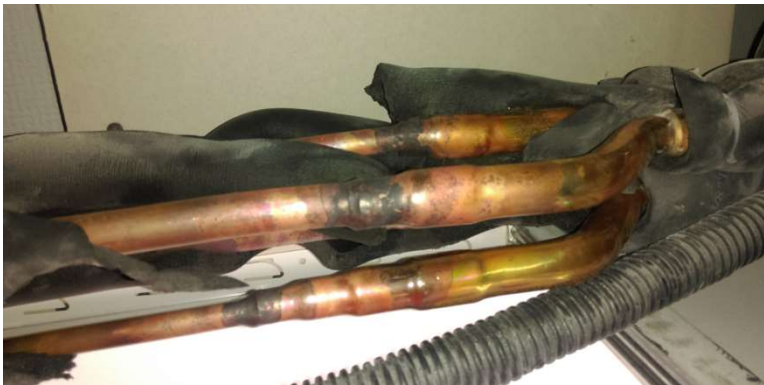
Before

Modify the pipeline. Remove the liquid pipe and gas pipe, exchange them, and weld them.

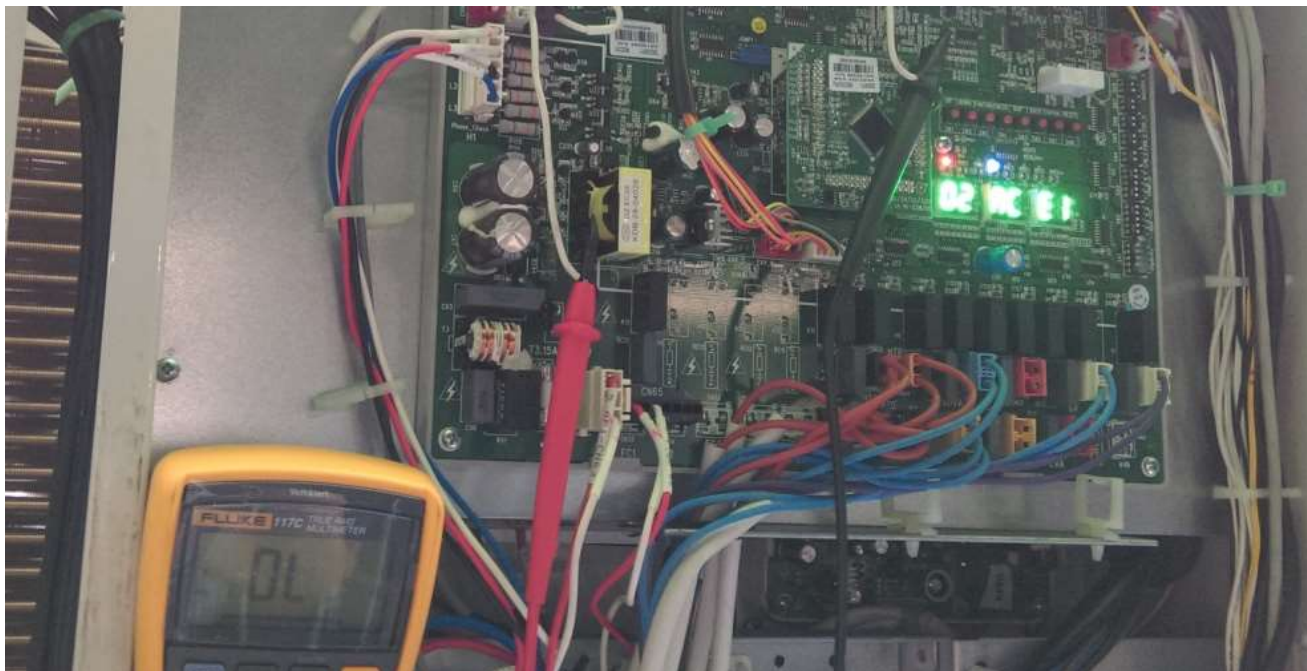
Secondly, when the unit displays E1 malfunction, use the multi-meter to test the high pressure switch is ok or not.

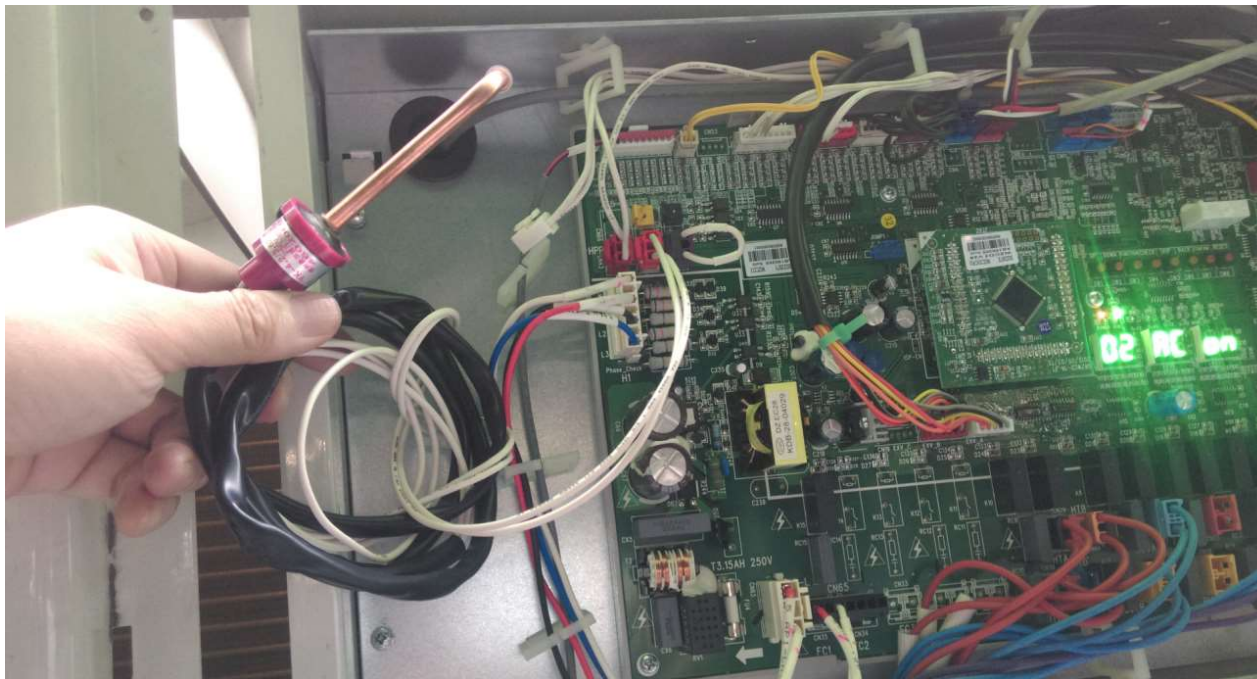
Thirdly, replace a new high pressure switch and then test run.  
Conclusion: The high pressure switch is broken. So that leads to E1 malfunction.

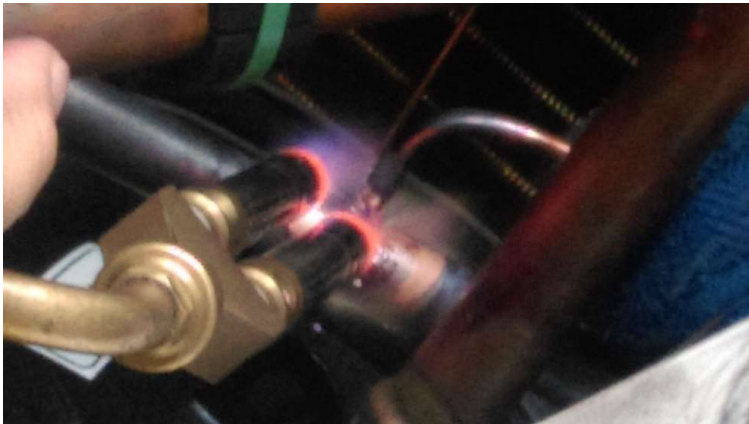
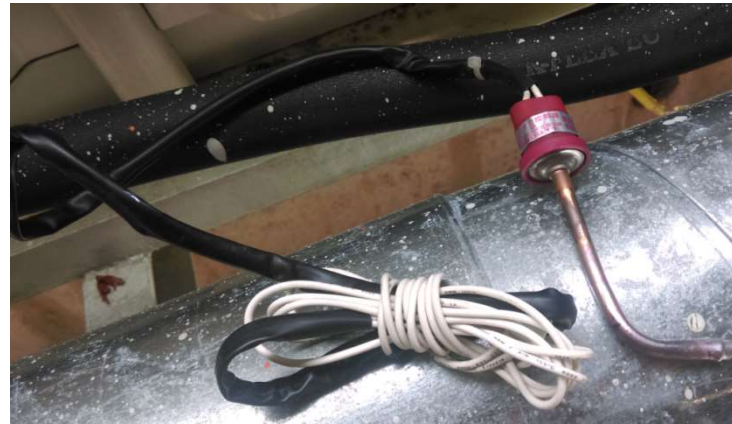
Replace a new high pressure switch.

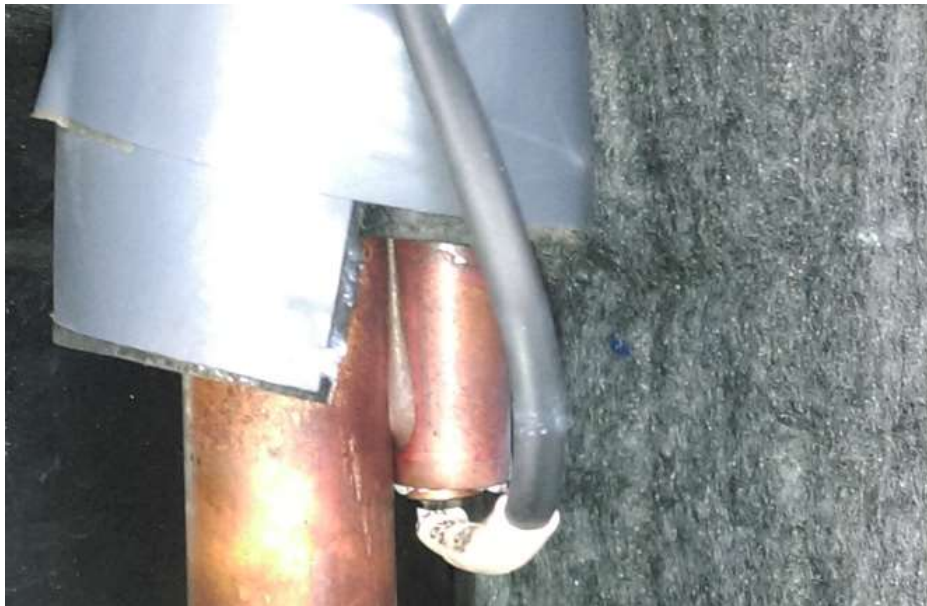
Thirdly, to fix the discharging sensor. And test the sensor to confirm if the resistance value is normal or not.
