# GMV5

GREE MULTI VRF SYSTEM

## GMV5 Key Parts Maintenance

Overseas Sales Co, GREE

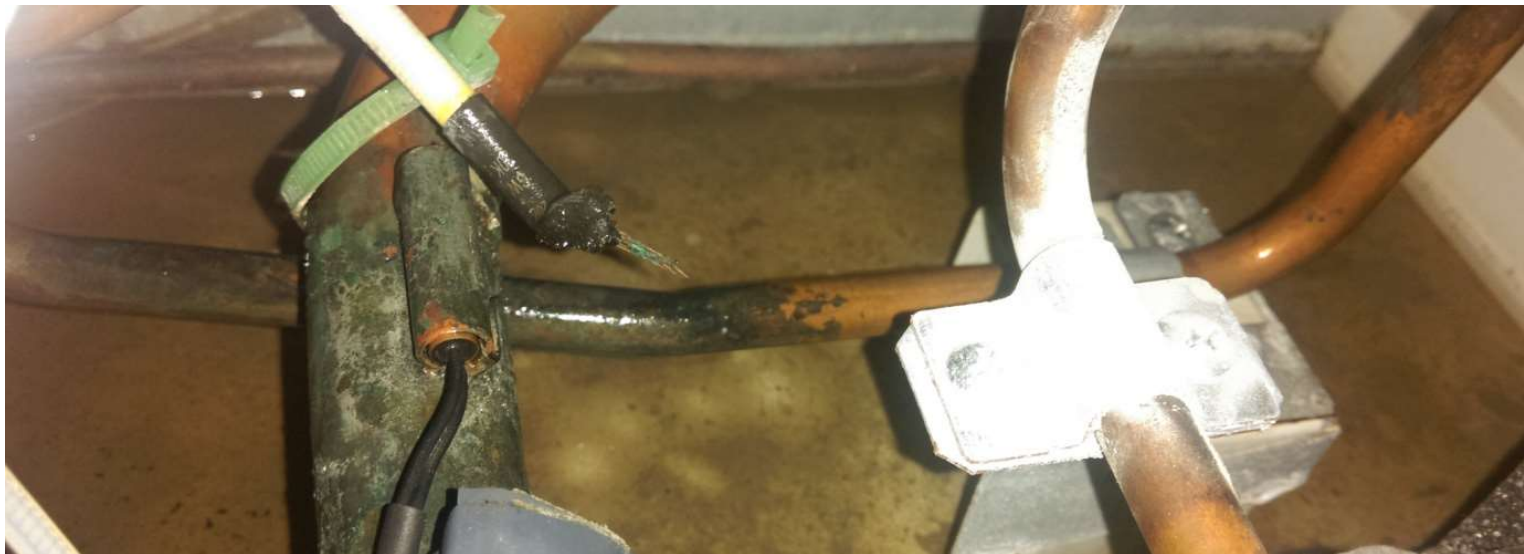
Fourthly, to check the IDU tube sensor. We find out that the sensor is not the ex-factory sensor. Our customer told us that the ex-factory sensor was broken and they bought a new resistance to replace the sensor from their local market.

Conclusion: The new resistance our customer bought from local market cannot work normally. That makes the EEX work abnormally and makes the discharging temp. low.

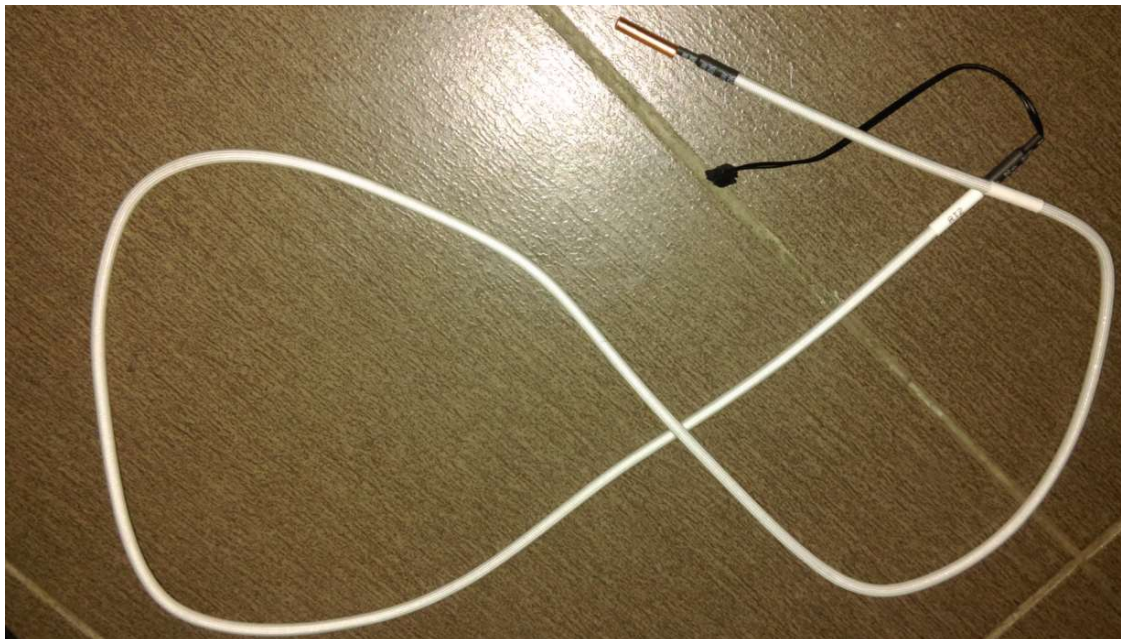
Replace a new IDU tube sensor. The sensor model should be accordance with the ex-factory specification.

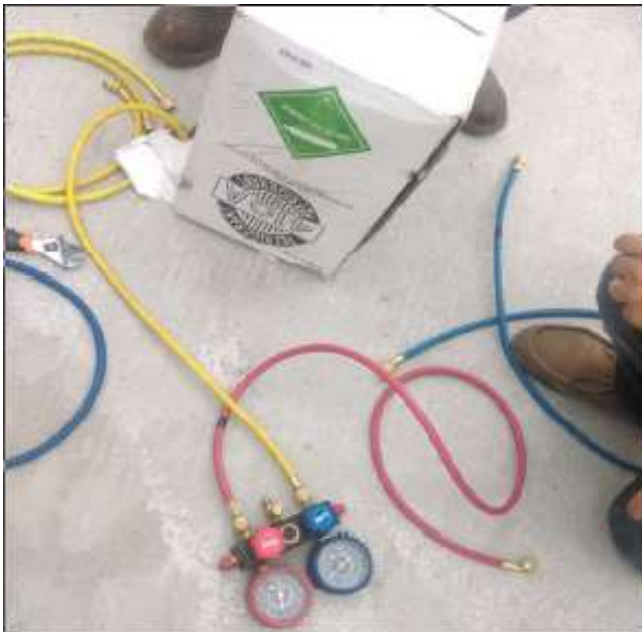
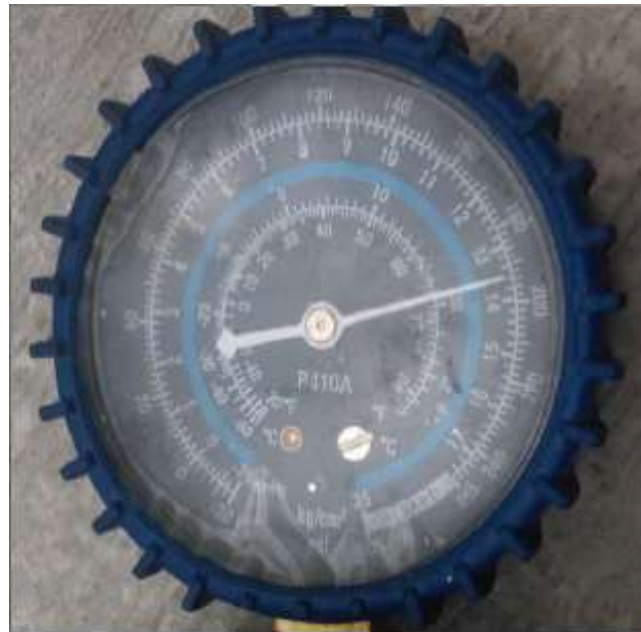
Thirdly, to judge the quality of the refrigerant is ok or not. Take one tin of the refrigerant from the system to test the refrigerant pressure. The pressure is 13.6 kilogram. The corresponding saturation temp. is about 20°C. And the outdoor ambient temp. is about 25°C. The difference is 5 °C. So, the refrigerant is not OK.

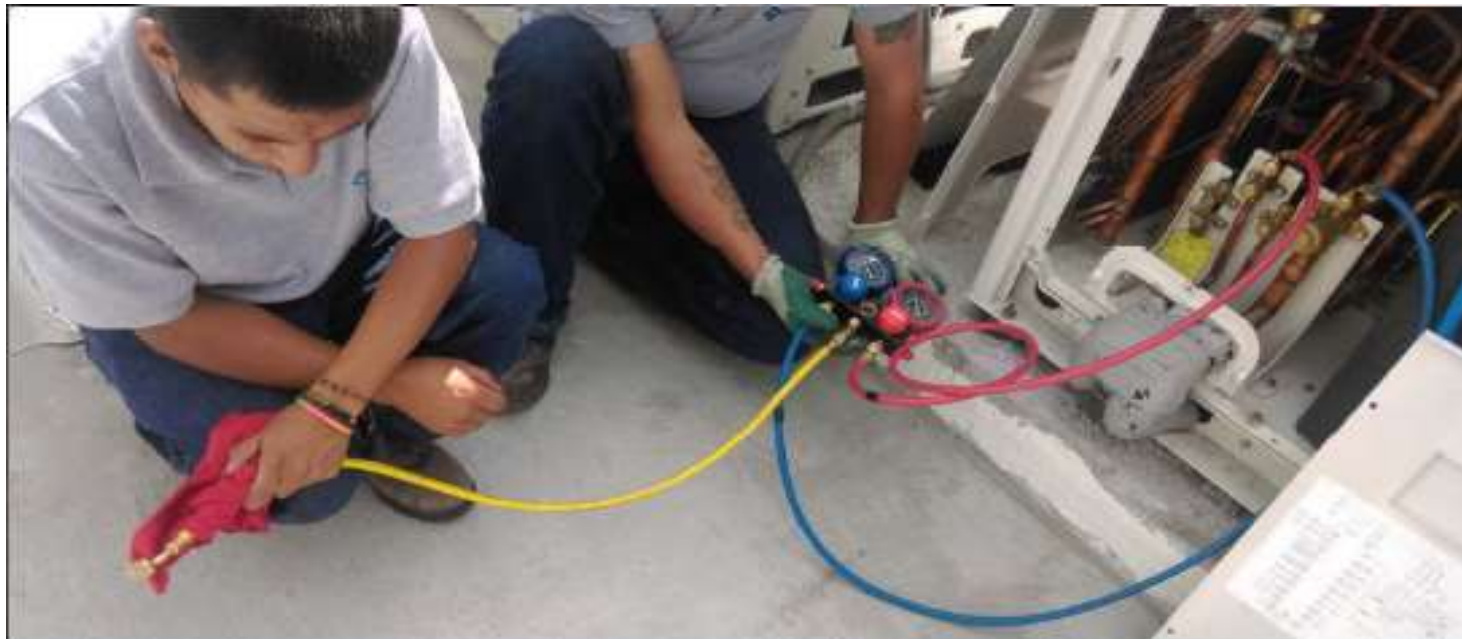
Fourthly, we try to release the refrigerant from the valves to judge the quality. Put your hand on the pipe nozzle find out that the refrigerant is not cool. We can judge the refrigerant is not OK.

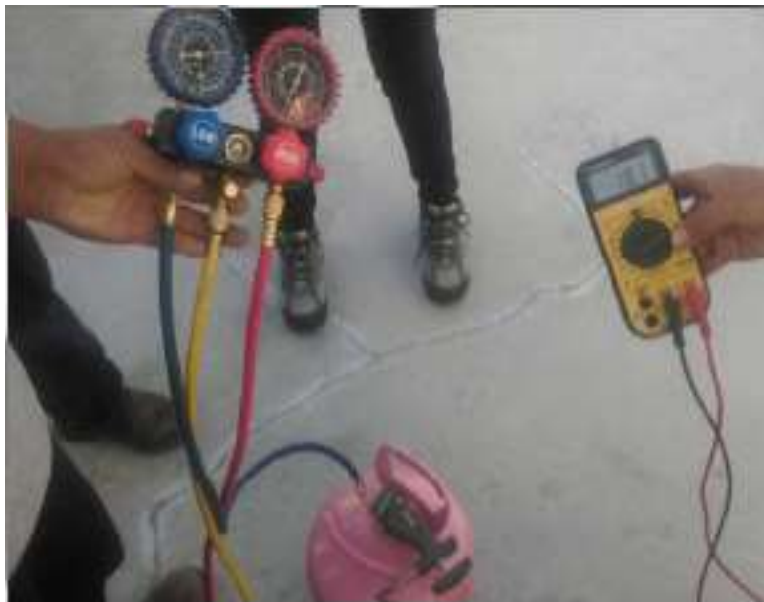
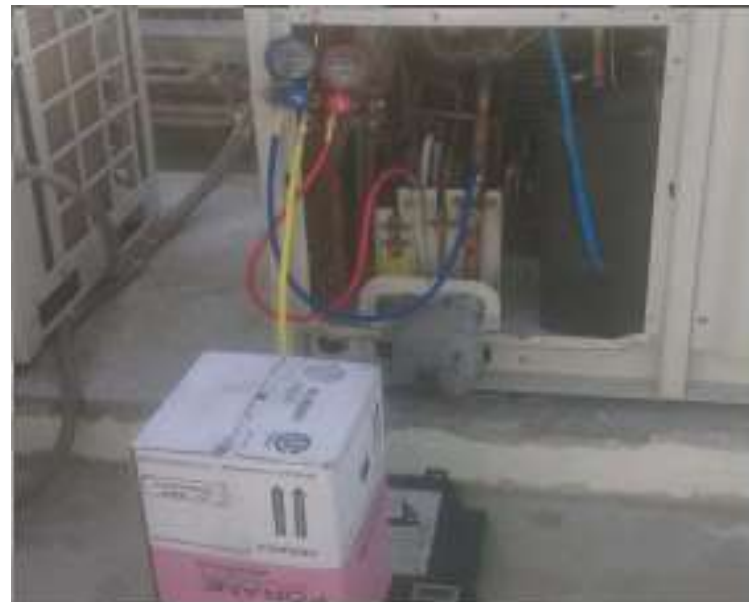
To replace new refrigerant. Buy qualified refrigerant. Test the saturation temp. and compare the ambient temp. The difference is  $1.5^{\circ}\text{C}$ . Judging the refrigerant is normal. Release the refrigerant. Vacuum the whole system. And then charge qualified refrigerant. At last run the unit.
